15 Years of Operating Experiences with Thick Nickel Plating Electrolytic Nickel Coated Tubes in Waste Incineration Plants – Protection against Corrosion –

Jörg Eckardt

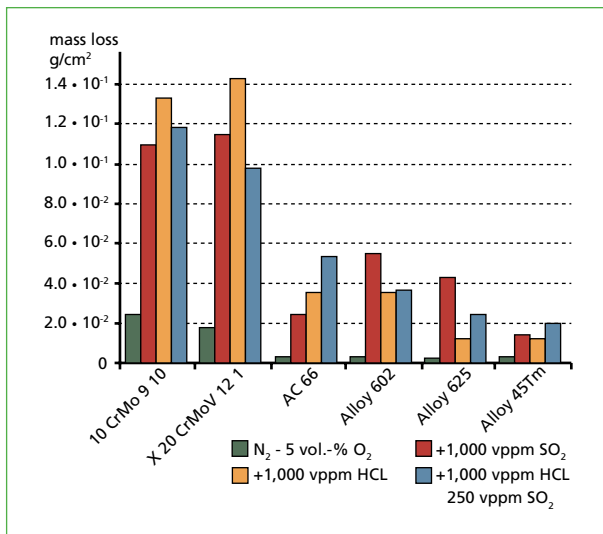
Figure 1:

Comparison of weight loss of steels and nickel base materials in different gas atmospheres under a molten $\text{CaSO}_4\text{-K}_2\text{SO}_4\text{-Na}_2\text{SO}_4\text{-PbSO}_4\text{-ZnSO}_4$ mixture at 600 °C after 360 hours exposure

The general fact, that applying protective coatings offers advantages is not under question any more. The principal factor in this phenomenon, as can be seen from Figure 1, appears to be the nickel [2, 3].

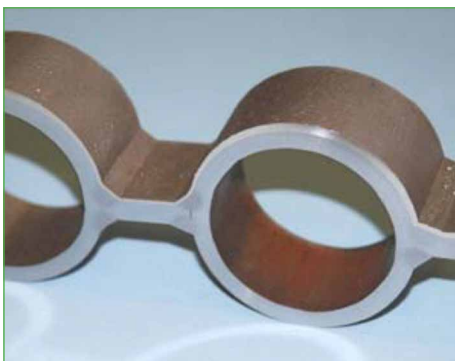
Figure 3: Latest quality of nickel layer

The process for manufacturing the nickel-plated tube has been advanced continuously and the quality improvement is amazing. Today, we can control thickness of the nickel layer and surface quality to an outstanding high level (Figure 3).
